The Bahamas
Maritime Authority

Marine Safety Investigation Report

into a lift fatality onboard Silver Nova on
22 February 2024

Date of Issue: 14 November 2024
Bahamas Maritime Authority
120 Old Broad Street
LONDON
EC2N 1AR
United Kingdom

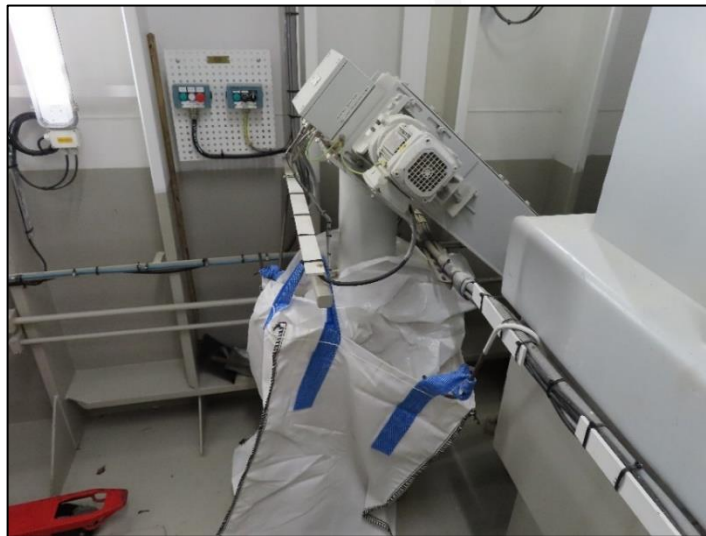
Figure 1. Incinerator ash discharge chute and bag

Both the IS and IO were responsible for ensuring that waste accumulated onboard is collected and segregated first for recycling, and any dry waste such as card, paper, wood as well as dried food is shredded into 25mm size pieces before it is fed into an incinerator. Once the ash from the incinerator is cooled, the ash is then loaded into large one-ton bags and shipped ashore when the vessel is alongside. (Figure 1)

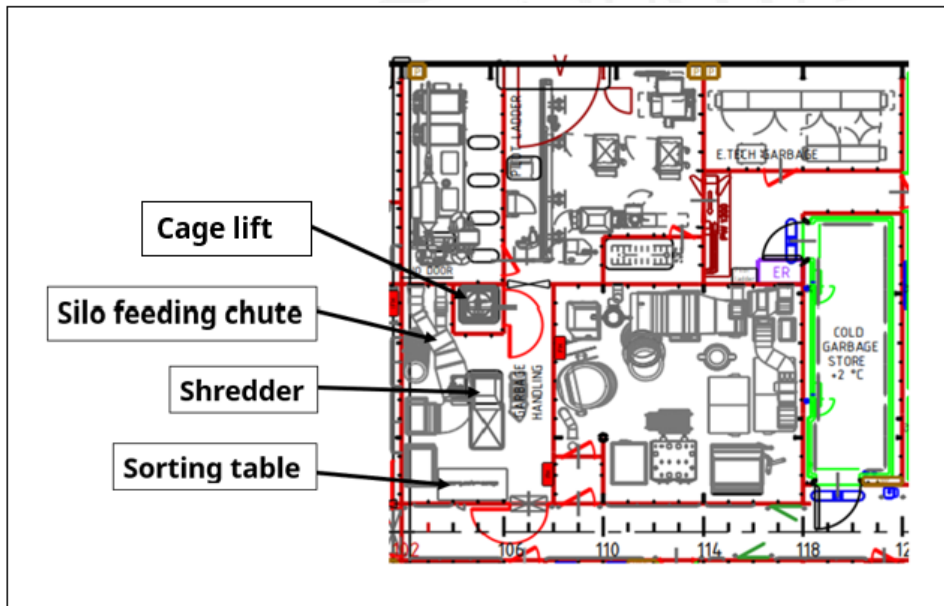
Figure 2. Deck 2 waste storage as depicted on extract from general arrangement drawing.

Following the conclusion of the morning toolbox meeting at 08:00 which was held in the engine control room (ECR), the IS and IO made their way up to deck 2 where the garbage handling area was situated (Figure 2). On arrival they commenced with separating waste for incinerating and other waste that would be recycled later,

where it would then be transferred to the provision handling area further aft of the garbage handling area ready for removal.

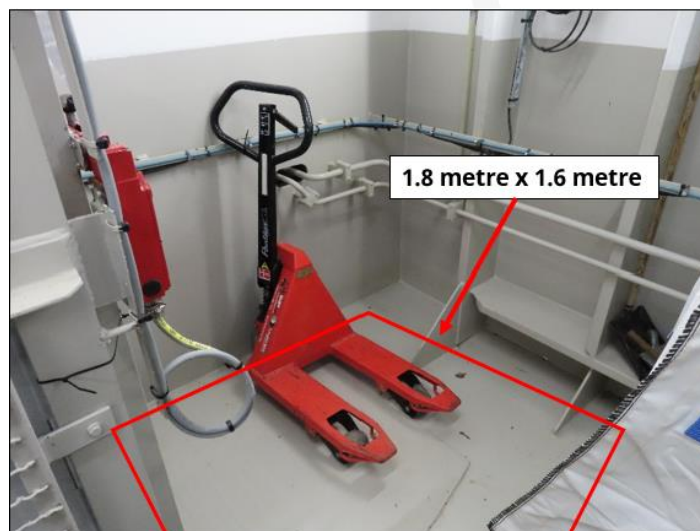
Figure 3. Available footprint to operate in along with a pallet truck.

The weight of the ash bag, coupled with a confined area in which to operate a manual pallet truck and the proximity of the discharge chute to the entrance to the cage lift, made transfer into the cage difficult for two crew, so a third person would often be called upon to assist (Figure 3). The cage lift was a custom-built unit to fit the allocated space and area in which it was to operate.

The cage lift when installed was positioned adjacent to the ash hopper chute allowing for proximity, however, did not factor in a suitable footprint or safe area for personnel working in and around the cage lift when transferring loaded ash bags by means of a manual pallet truck.

The need for a manual pallet truck in an already confined space removed any available safe area to manoeuvre the loaded ash bag and made handling and transferring the bag into the cage difficult, requiring the assistance of a third person to assist in manhandling the bag into the lift.

- **Silversea S.A.M** revise its manual handling and associated risk assessments to reflect work as done and adapt workplace design and/or practices to effectively mitigate risk.
-

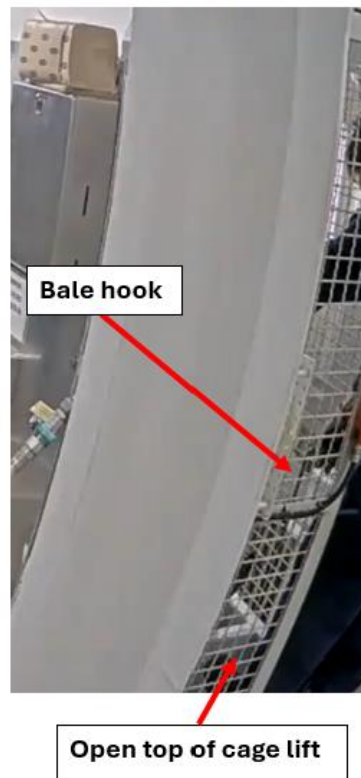
Figure 4. CCTV extract showing IS and IO accessing the open top of the cage lift to grab the ash bag.

Although access and working space was limited, the IS and IO accompanied by the wiper managed to manoeuvre the bag resting on the pallet truck into the cage lift. The ash bag was proving difficult due to its weight and its position, so the IS and the IO made their way back up to deck 0. The IS opened the access gate with an over-ride key he had taken from the ECR and with the use of some bale hooks, they both climbed on to the top frame of the cage and leaning through, gathered up the handles on the ash bag in the cage below to try and move it centrally (Figure 4).

Furthermore, the configuration and layout of the cage lift required the IS to routinely open the side access gate using the over-ride key in order to scale the top frame of the cage lift. This means of access and the additional task of reaching down through the top of the cage to grab the ash bag handles was not covered in any pre-planning meeting or addressed as part of the ship's manual handling risk assessment.

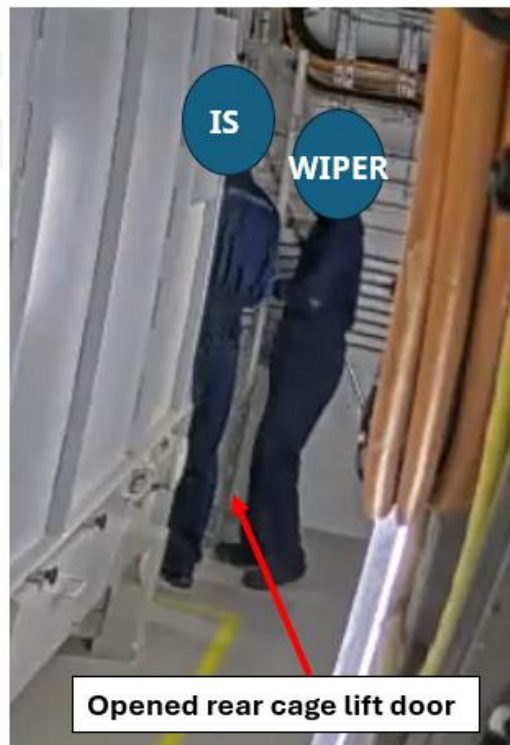
Figure 5. IS and wiper opening the rear cage lift door.

The IO returned with a pole and along with the IS tried to hook a tie handle in an attempt to move the bag. The wiper summoned the IS to open the rear access gate so that the ash bag could be accessed (Figure 5). The IS opened the gate following a discussion with the wiper and returned to the IO at the front. The wiper then entered the cage lift to free the bag.

At 10:35 the wiper who was stood with one leg inside the cage on the edge of the pallet, and his other on deck was manhandling the ash bag when suddenly it dislodged, and the cage plummeted more than 2 metres towards deck 0. The wiper's upper leg, pelvis and lower abdomen ended up crushed and trapped between the deckhead on deck 0 and a support bar on the upper section of the cage lift.

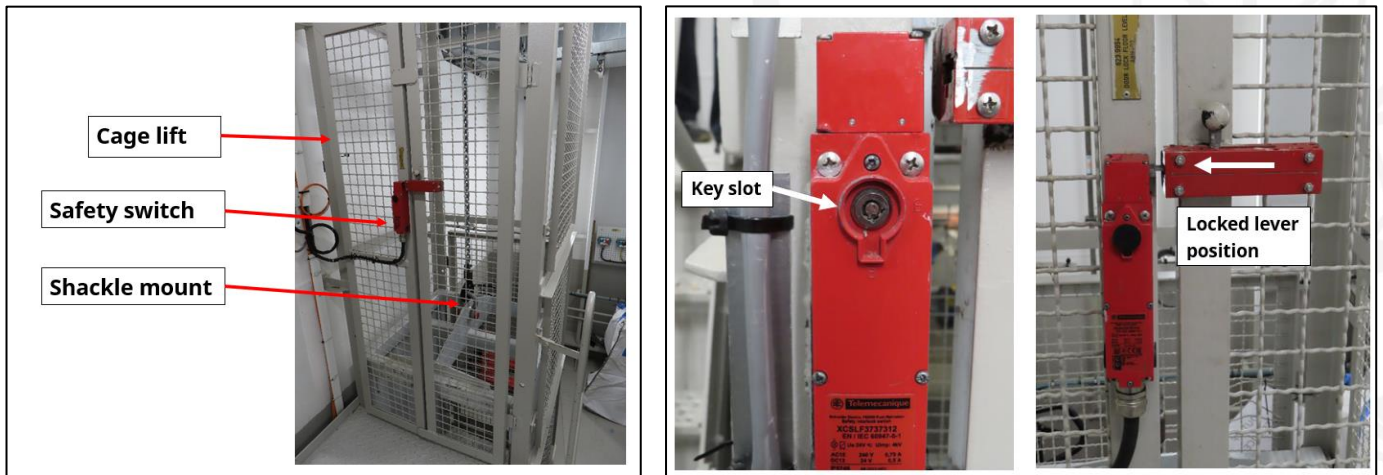
Figure 6. YALE cage lift located on deck 00.

The cage lift manufactured by Yale with a safe working load (SWL) of 700 kg was a purpose-built design during the new build phase of the vessel and comprised several safety features, including emergency shut-offs, limit switches, safety switches and horizontal bars (Figure 6). The lift also comprised additional safety features whereby the lift would not operate if the cage doors were not properly closed or if limit switches were incorrectly set or out of position during operations.

Although fitted with several safety features, no considerations were factored into the design to provide a suitable means of reducing the potential for a slack chain from forming, or a means to alert operatives.

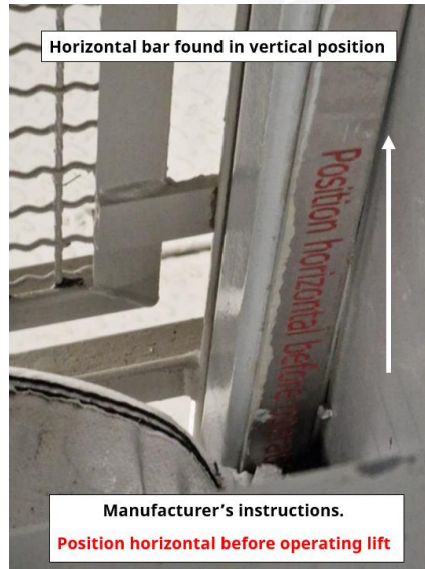
Figure 7. Horizontal bar found in vertical position.

The cage lift got wedged when an ash bag shifted during hoisting as a result of horizontal bars not being in place that were fitted to prevent cargo from spilling out from under the gate during loading.

The two horizontal bars fitted are to be lowered in sequence, with the inner one being lowered first at the rear of the cage before loading commences followed by the second one on completion of loading prior to closing the gate. These bars act as a barrier to prevent any load carried from snagging or spilling out from the bottom of the cage during hoisting operations (Figure 7).

The lack of oversight in lowering the inner horizontal bars when loading commenced, was most likely due to distraction resulting from the task at hand of loading the ash bag into the cage lift. Additionally, the cage did not clearly inform users of their purpose or indicate the importance in lowering them when loading commenced or on completion prior to closing the cage door.

- The manufacturer's instructions on the importance in lowering the horizontal bars as part of lift operations was not clearly marked on the cage lift.

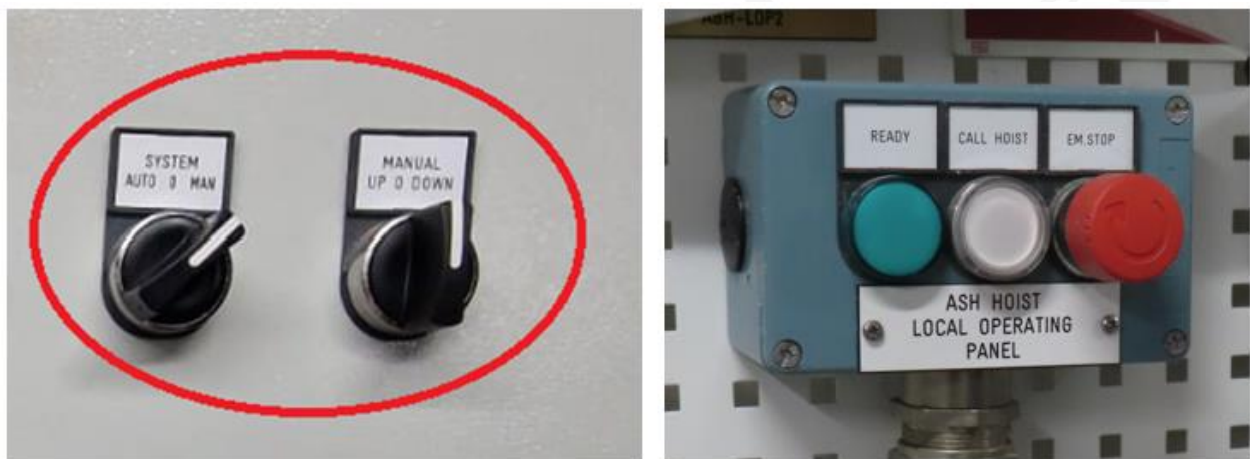
Figure 8. Main control box switch and smaller control box switch

The operation of the lift was controlled by a main control box on deck 0 with smaller control boxes situated on deck 1 and 2. The main control panel featured two switches allowing for the operator to operate it in either auto or manual mode and the other switch to select either an up or down function.

In auto mode, lifting can be operated by anyone pressing the call hoist button on any deck level. The manual mode requires the switch to be manually set and controlled from each box on each deck level by first ensuring the ready button is activated before calling the hoist. Each control is fitted with an emergency stop button and the cage lift can be stopped on any deck level regardless of whether it is set to manual or auto.

On the day the casualty, the controls were set to manual (Figure 8). Although the IS had followed training and safety protocols in deactivating the cage lift by isolating the power supply, no visible checks were carried out by either himself or the IO to verify the tension of the chain or whether the horizontal bar was lowered in place prior to hoisting.
