# Marine Safety Investigation Report

into the sinking of Islander III on  
14 November 2023

Date of Issue: 14 November 2024\*

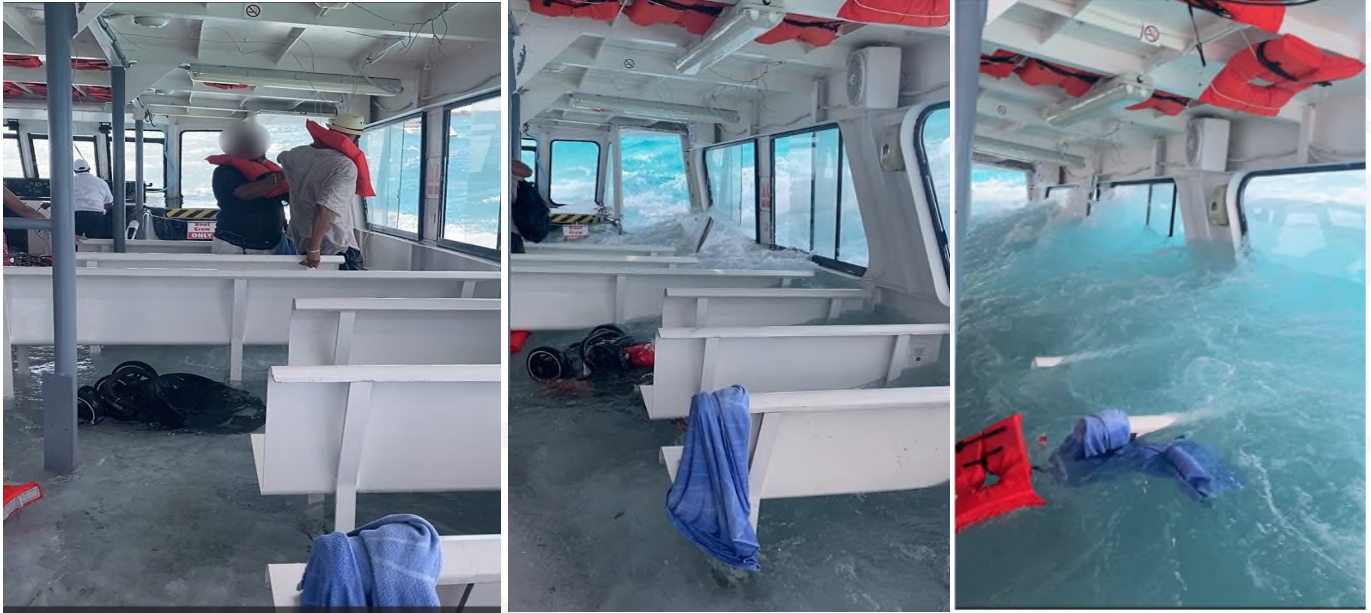
This action resulted in the bow of the vessel digging deeper into the water. The boat master experienced increased difficulty in steering and tried to manoeuvre to regain control of the vessel. Aware of the developing situation, the boat mate began to remove stowed lifejackets from overhead, and the crew assisted in handing them out. Passengers were also prompted to move towards the aft of the vessel or to the upper deck.

**Images of initial water ingress, leading to progressive flooding after power increase (Source: shared by member of public)**

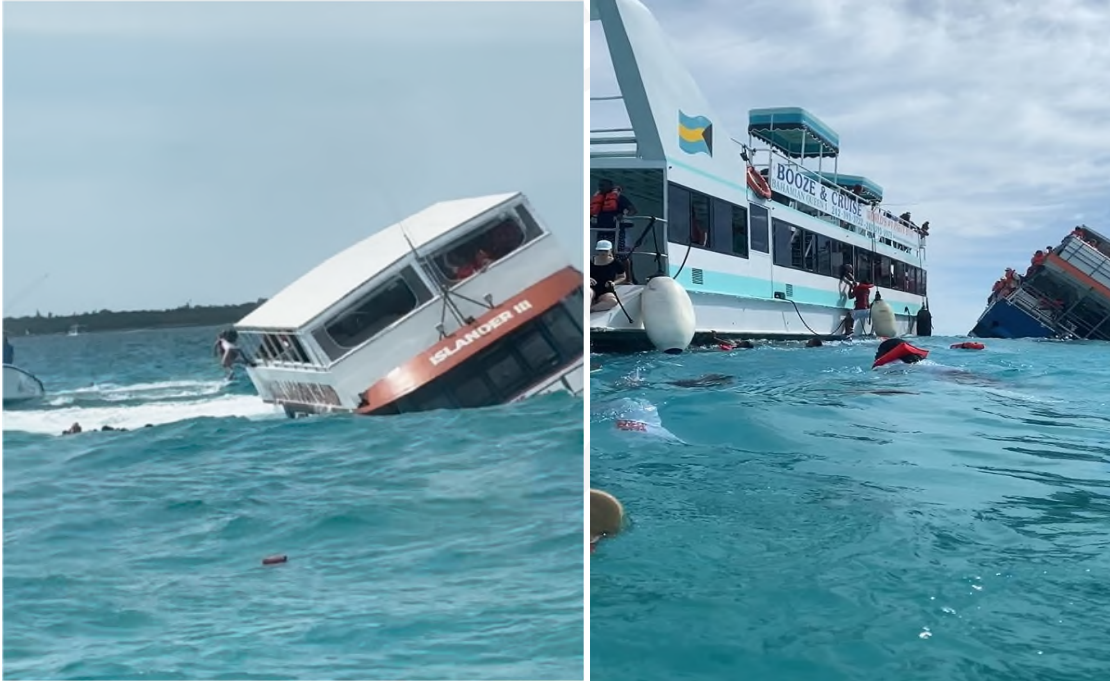
**Left: Islander III with engines running and passengers jumping into the sea.  
Right: Booze & Cruise approaching port side to assist in transfer of passengers  
(Source: shared by member of public)**

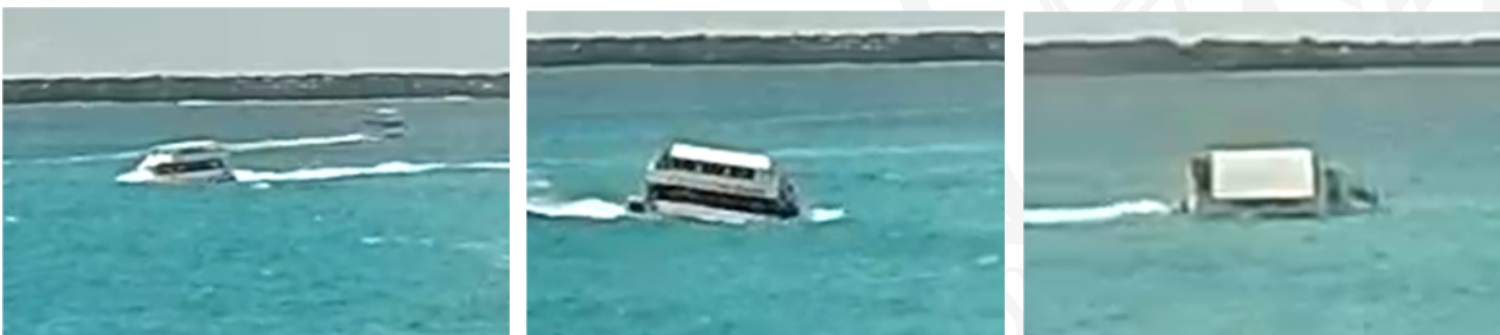
This created a detrimental cycle of the bow becoming increasingly heavier, causing a significant reduction in freeboard forward, and the vessel eventually developing a significant starboard list.

**CCTV images from WeatherSTEM station showing Islander III arriving with forward trim and eventually listing to starboard**

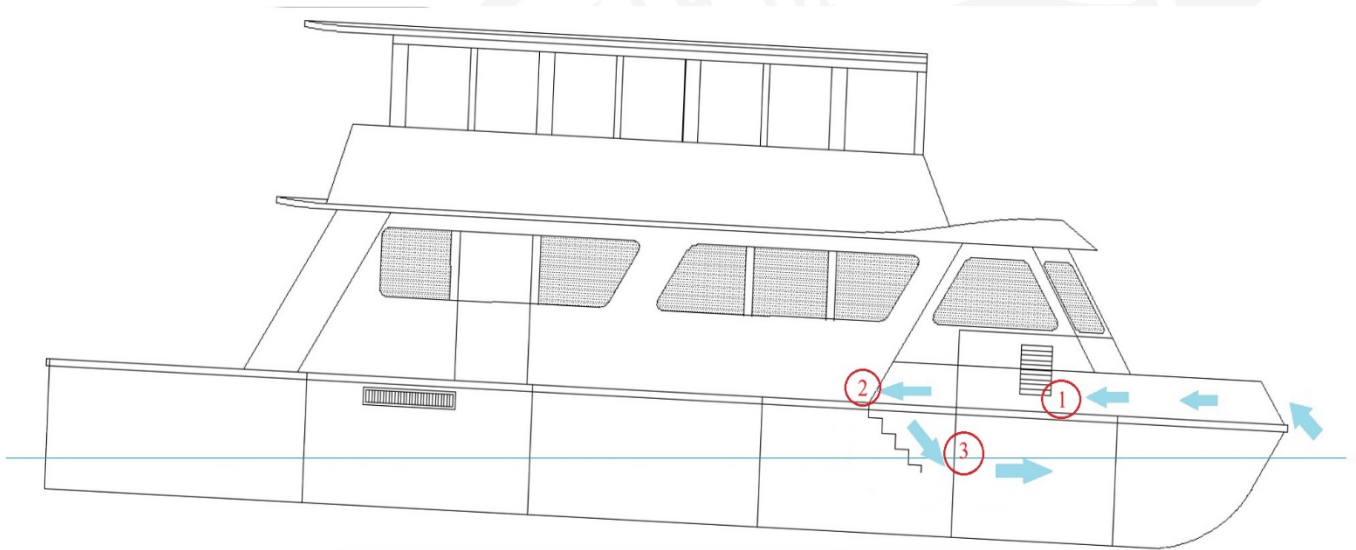
With a low freeboard, compounded by a forward trim, an enclosed bulwark and inadequately sized freeing ports, water shipped over the open bow was easily entrapped. The accommodation door was not of a weathertight construction, allowing unrestricted passage of water from the deck into the accommodation:

**Representation of water progression with Islander III with forward trim**

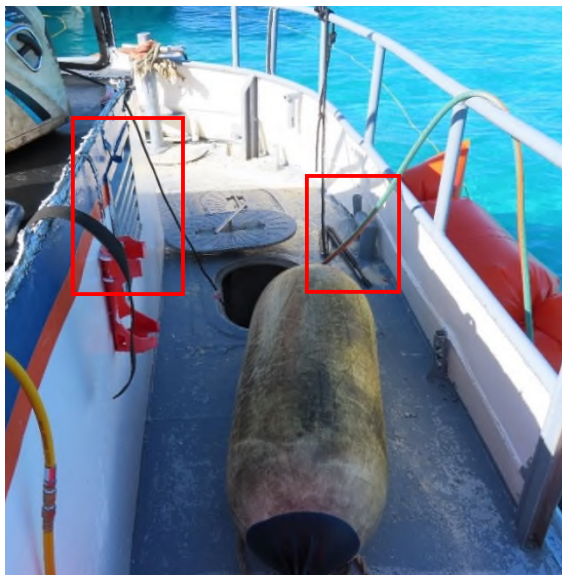
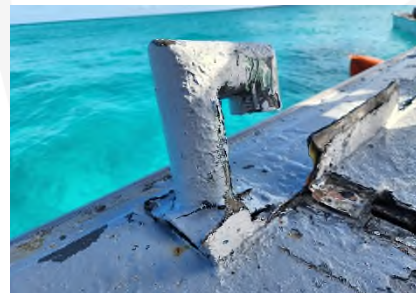
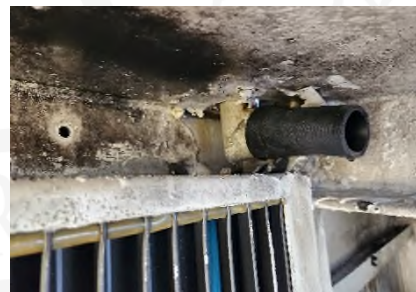
Focus point ① represents the ventilation for the bathroom and a gooseneck vent for a void space located on main deck starboard side. Both vents were naturally ventilated with no watertight protection fitted. Additionally, the point of down flooding for the vents were at a lower level than the surrounding bulwark. The bathroom vent and gooseneck vent were located forward of the first freeing port on the starboard side. These vents were a significant risk to water ingress directly to the hulls.

**Focus Point 1: Refloated hull of Islander III. Left: Bathroom vent and gooseneck vent. Right: Gooseneck vent without flooding protection**

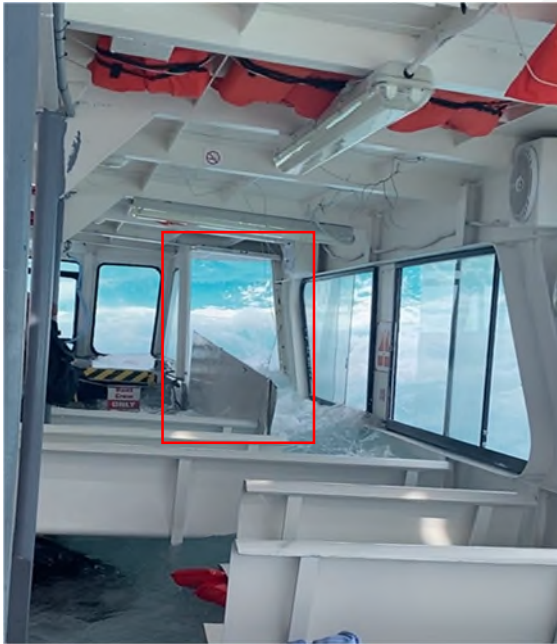
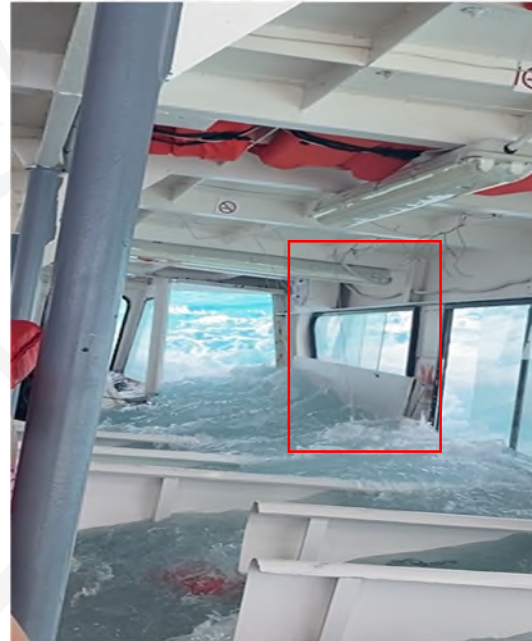
Focus point ② represents the door fitted between the bow and accommodation, which was the only barrier against water ingress from main deck into the accommodation. Being of plastic construction and

relying on a small wire latching mechanism for securing shut, it was not weathertight. Images below show dislodging of the door fitted.

**Focus Point 2: Lightweight door fitted on Islander III being dislodged (Source: shared by member of public)**

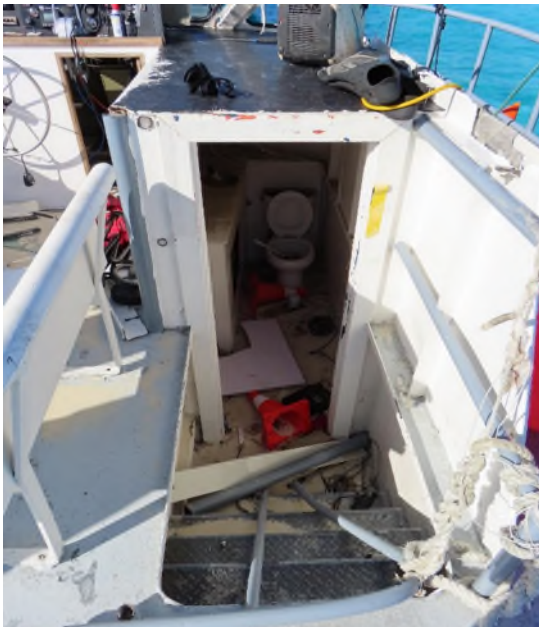
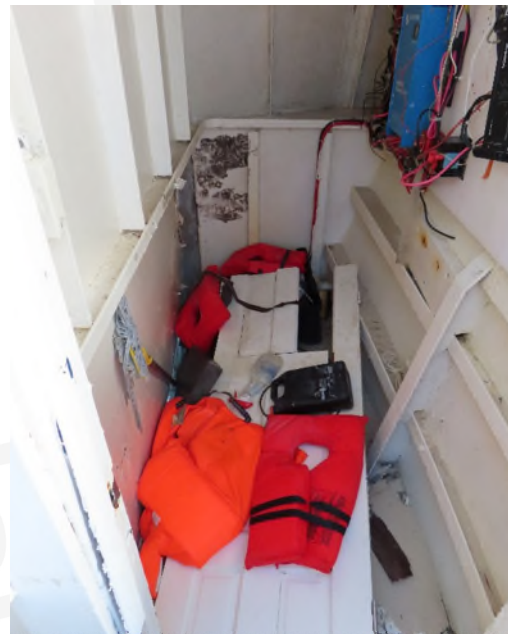
Focus point ③ relates to the bathroom entrance space and door. The staircase leading to the bathroom combined with the bathroom area had a volume of 4m<sup>3</sup> below deck level. The bathroom door was not of a weathertight design, therefore water from deck could flood the space without restriction. The bathroom door of Islander III was not recovered.

**Focus Point 3: Left; Islander III refloated hull bathroom entrance  
Right; previously fitted door on battery room**

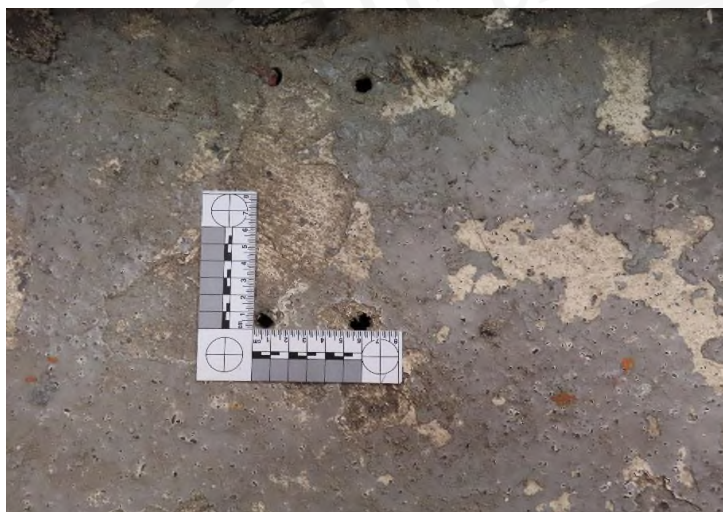
In addition to the flow of water beneath the bathroom door, and water ingress from the bathroom vent, the flooring in the bathroom had holes drilled allowing water flow into the void space below. The intent of this design is for the water to be pumped into a bilge tank automatically via the bilge pumps. An example of the same holes are shown below, taken from Islander II. These holes are 10mm in diameter.

**Islander II: Holes drilled in the bathroom floor to allow drainage of accumulated water**

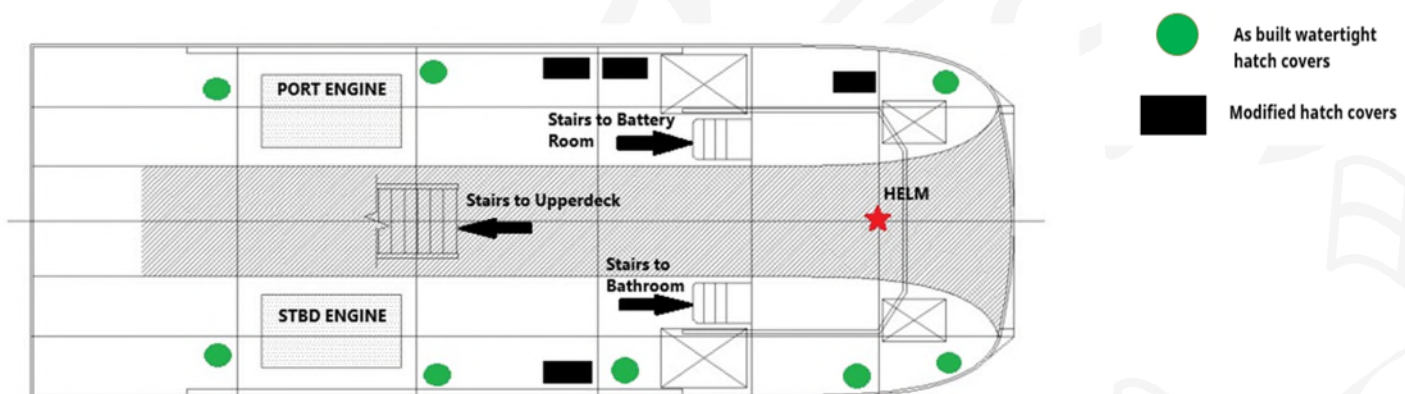
Access to the void spaces and rudder room was originally via watertight hatches in the deck. Alterations to the vessel had resulted in four of these hatches being replaced with non-watertight equivalents.

**Islander III: general arrangement indicating as-built watertight hatches and modified covers (drawing not to scale)**

The design of these retrofitted hatches did not allow for them to be secured and they were not fitted with any gasket or other means to protect the space from water ingress. These spaces were also fitted with goosenecks vents. Those that were found intact were not fitted with any flooding prevention.

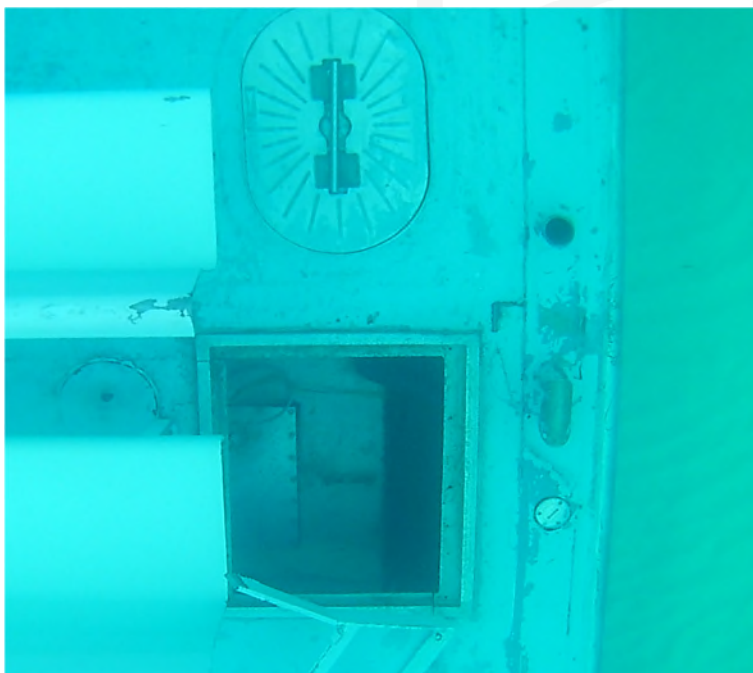
**Islander III on the seabed: retrofitted hatch to fuel tank compartment (cover washed away during sinking), next to original watertight hatch**

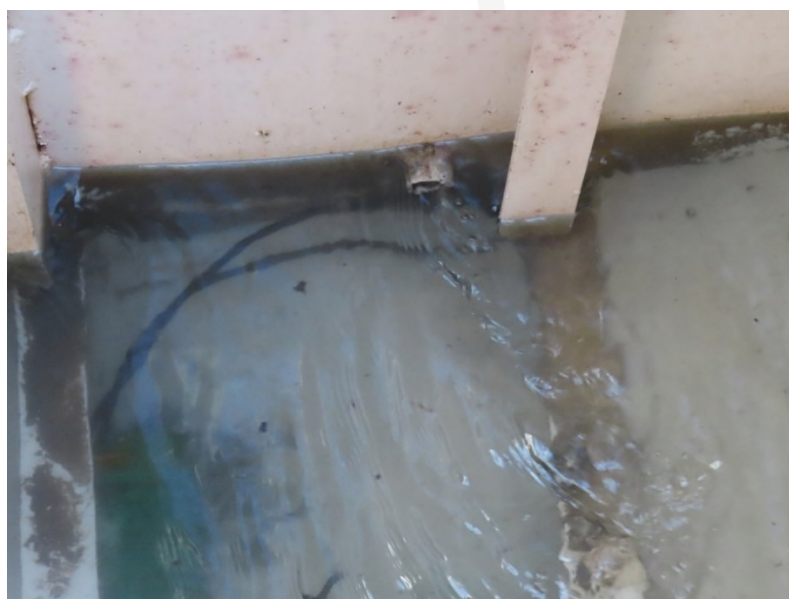
Examination after refloating Islander III identified that the void spaces were communicating – flooding into one space resulted in water flow to adjacent spaces.

**Islander III refloated hull: bulkhead penetrations allowing flow of water between compartments**

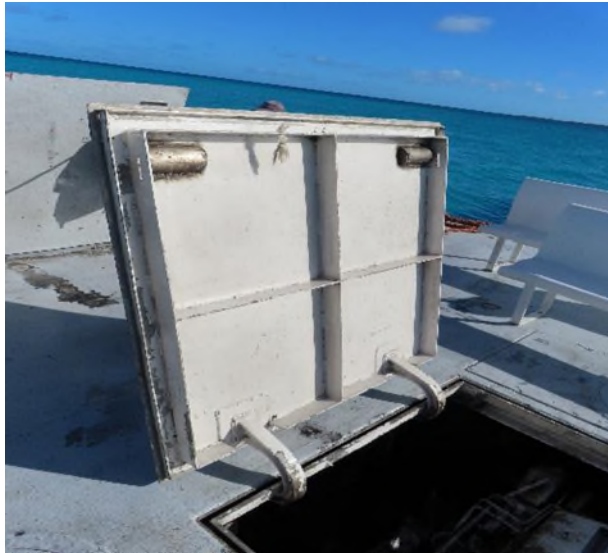
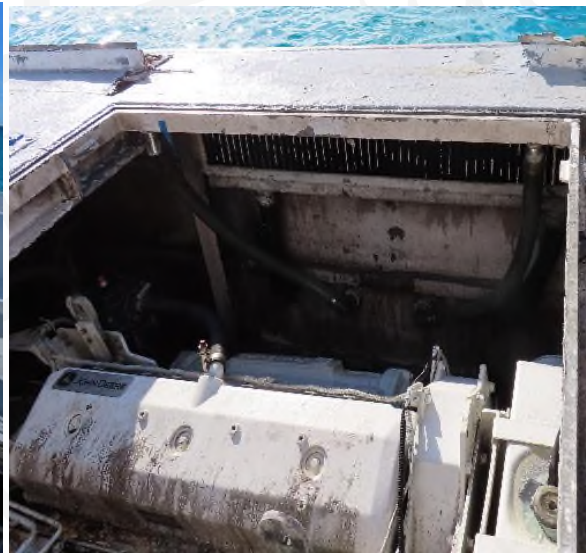
The engine room spaces were accessed via a hinged hatch, the hatches could not be secured (they remained in place by gravity) and they were not fitted with gaskets. The compartments had through-hull air intakes with no flooding prevention mechanisms fitted. Located beneath the deck line, this air intake design further compromised watertight integrity.

**Engine room hatch - no dogs or gasket. Air intake without flooding protection**

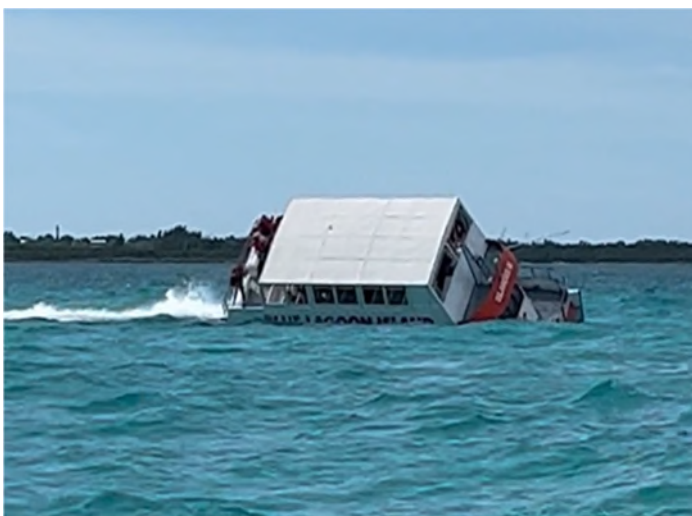
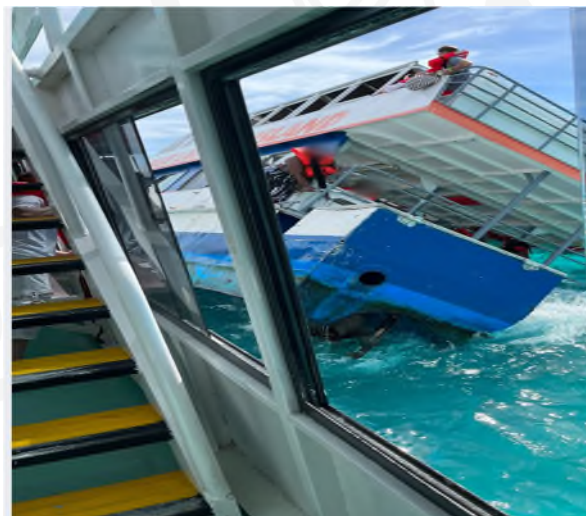
With the boat master still trying to free water from the deck over the stern, an incredibly dangerous situation developed with passengers jumping into the water while engines were still running. The starboard list also caused the port propeller to be at, or above, the waterline and this in turn resulted in the vessel losing steering and causing the vessel to spiral.

**Passengers beginning to abandon ship while engines running and vessel beginning to spiral while passengers still in water (Source: shared by member of public)**

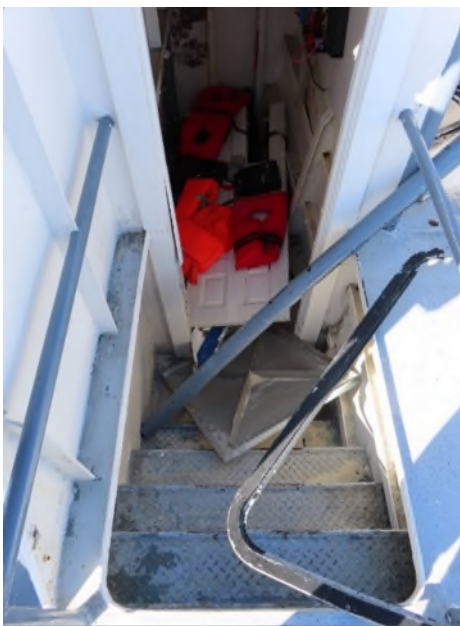
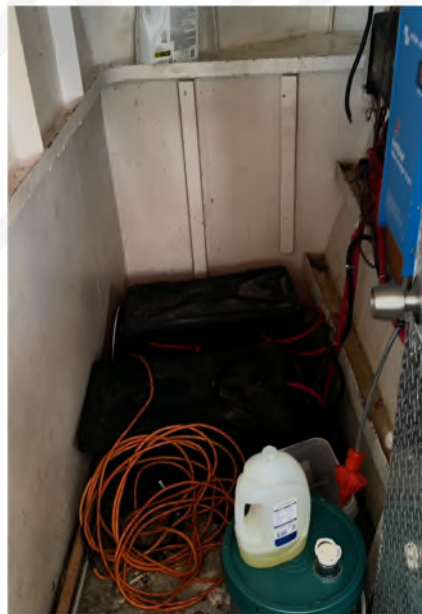
The batteries and battery charger were located in a recessed room on the port side of the vessel. The space was also used as a store room, further adding risk to compromising the batteries while underway. The door to the battery space, and casing for the batteries lacked any watertight protection. In addition, the batteries inside their case were fixed on the deck, rather than mounted or elevated: the batteries were submerged with a relatively small amount of water ingress rendering any form of battery powered communication, including the public address system and VHF radio, ineffective.

**Left: Battery/Store room on refloated Islander III Right: Battery/Store room on board Islander II**
