Marine Safety Investigation Report

VERY SERIOUS MARINE CASUALTY | January 2024

Constellation

Steam release fatality 10 February 2024

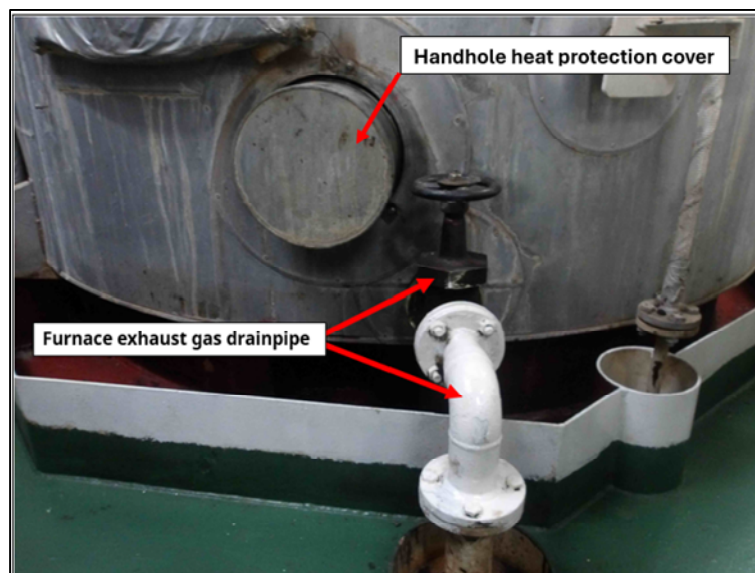
Following an inspection on the morning of 10 February 2024, it was identified that the furnace exhaust drainpipe was blocked with carbon deposits. A fitter, motorman and a wiper were assigned the task of removing the furnace drainpipe and unblocking it.

Base of auxiliary boiler

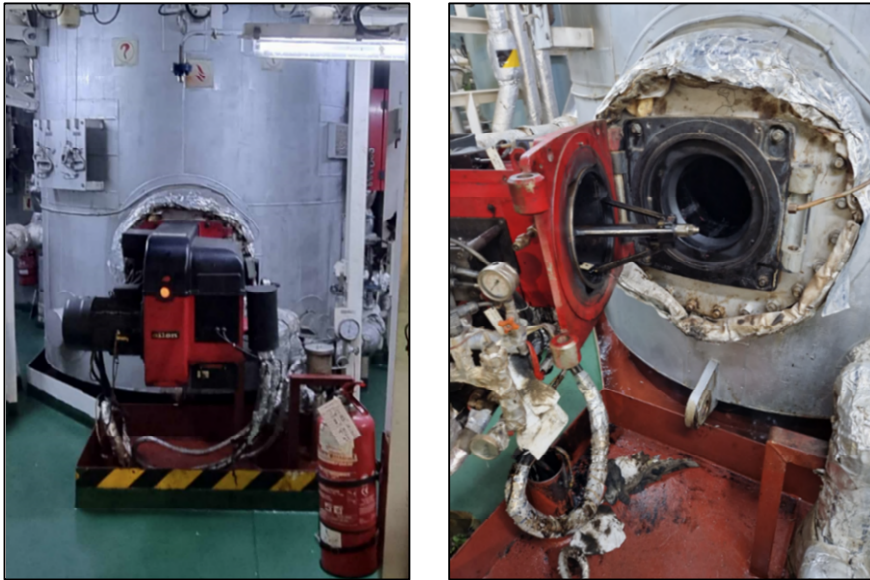
Auxiliary boiler with burner closed (left) and open during maintenance.

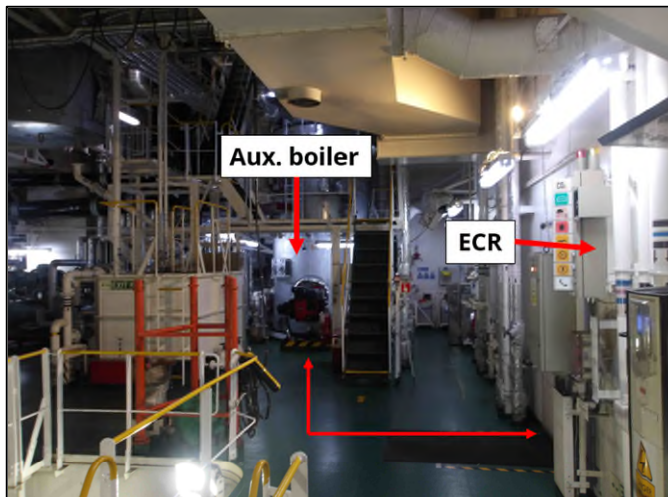
Proximity of ECR to auxiliary boiler

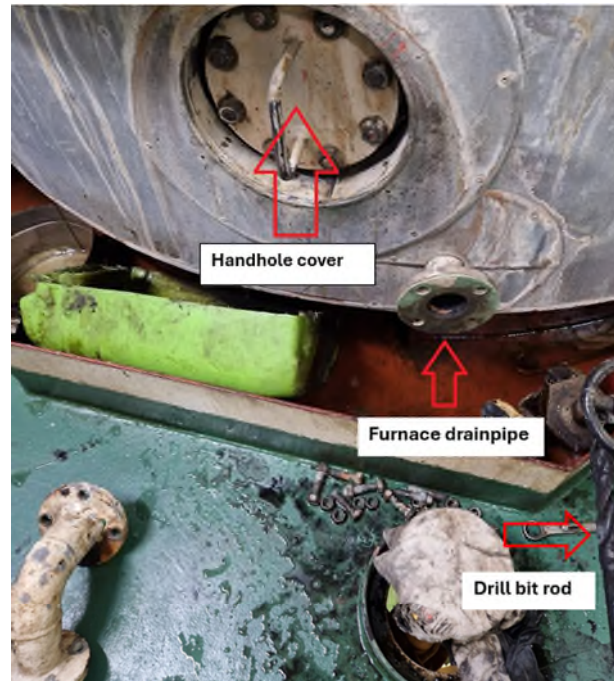
drainpipe within the base of the boiler was clogged. The wiper and fitter were instructed to unclog the furnace drainpipe first before attempting to flush it through.

Furnace drainpipe and heat protection cover removed

The drain itself was prone to clogging – so much so, that the crew had manufactured a tool to clear the blockage - an opportunity was missed in the design of the drain to prevent clogging, thereby negating the need for manual intervention to unblock it.

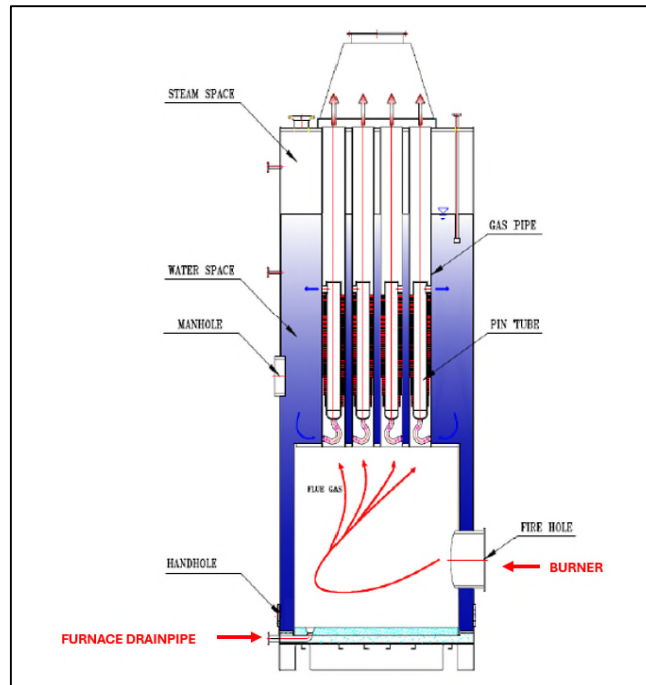
The fitter took a decision to open up the handhole cover in the belief that he could gain access to the furnace drainpipe in order to unblock it. Unknown to him or the crew he was working with, the cover actually gave access to the water side of the boiler which was full of water at 127°C and pressurised to 2.5 bar.

The fitter took hold of the hammer and proceeded to hit the handhole cover, and at 08:45 the cover sprung loose resulting in the sudden release of steam and hot water which engulfed the fitter, the lower abdomen of the motorman and scalded the wiper's arm.

Cross-section of auxiliary boiler

The cause of injury was the sudden release of pressurised hot water and steam when the fitter opened a sealed handhole cover to the water space of the auxiliary boiler that was filled with water at 127°C and pressurised to 2.5 bar. The fitter was not familiar with the arrangement of the boiler and unaware that the space would be pressurised with steam or hot water present.
