# Marine Safety Investigation Report

into the sinking of Islander III on  
14 November 2023

Date of Issue: 14 November 2024\*

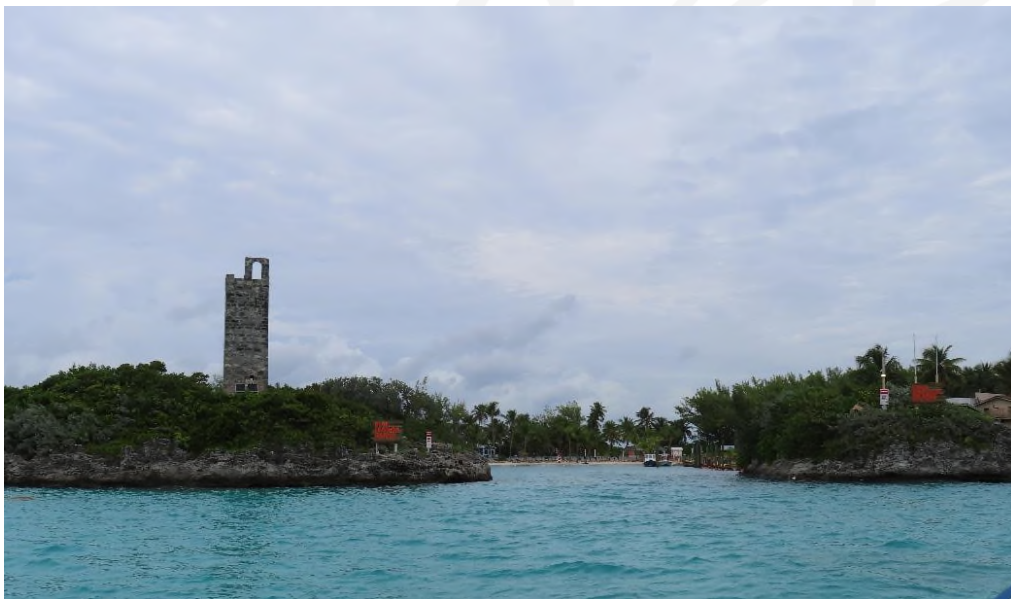
**Main entrance into Blue Lagoon Island**

The boat master arrived at the vessel and received a handover from the boat mate. The Islander III then left the Bay Street Dock at 06:47, for a crew run: the passengers were the staff of Dolphins Encounters Ltd, who work on Blue Lagoon Island. Upon approach to Blue Lagoon Island, the main entrance was inaccessible due to the sea gate being stuck.

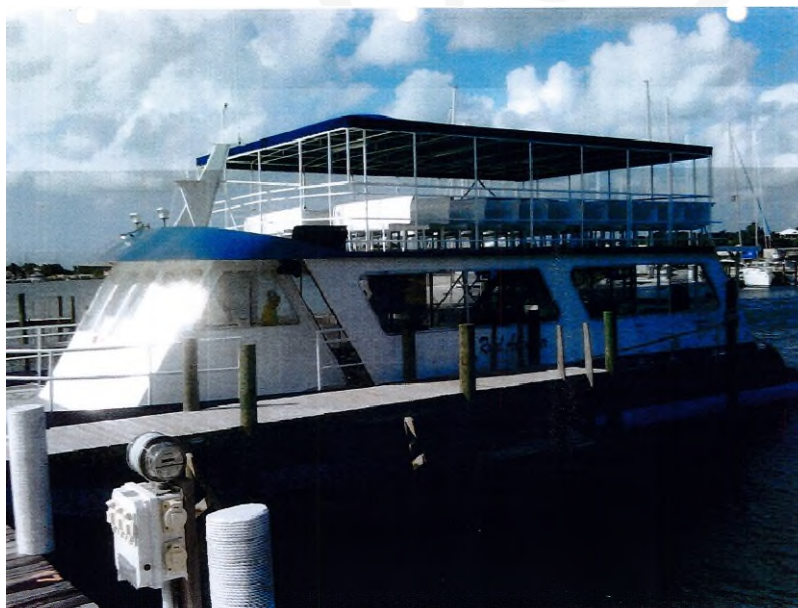
Photo from 2010 survey

Prior to entering the Blue Lagoon Island fleet, Islander III was subject to a pre-purchase survey conducted on 1 September 2010, at Marsh Harbour, Abaco. The inspection was conducted to the “standards and practices of the New Providence Port Authority.” The primary items of focus during the survey were the hull and machinery condition. No fixed or semi-fixed items were removed and no sea trials were conducted.

The survey concluded with recommendations to install a CO<sub>2</sub> fixed extinguisher in the engine spaces, repair a damaged window and secure life-jackets topside in an easily accessible condition.

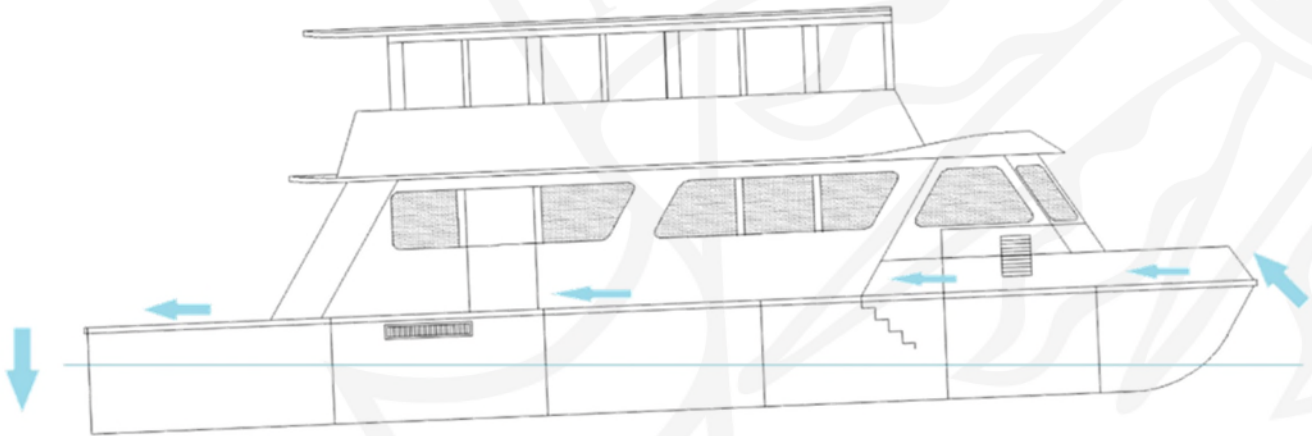
**Boat master’s mental model of Islander III trim for water flow**

When it became apparent that there was water trapped on deck, the boat master’s mental model was that the solution was to engage engines ahead, to free water over the stern. This was only achievable if the vessel was trimmed by the stern, its usual operating condition:

Islander III arrived at the main entrance to Blue Lagoon Island with a forward trim. The boat master’s attempt to free water from deck resulted in driving the bow further into the next set of waves.
