Marine Safety Investigation Report

VERY SERIOUS MARINE CASUALTY | January 2024

Constellation

Steam release fatality 10 February 2024

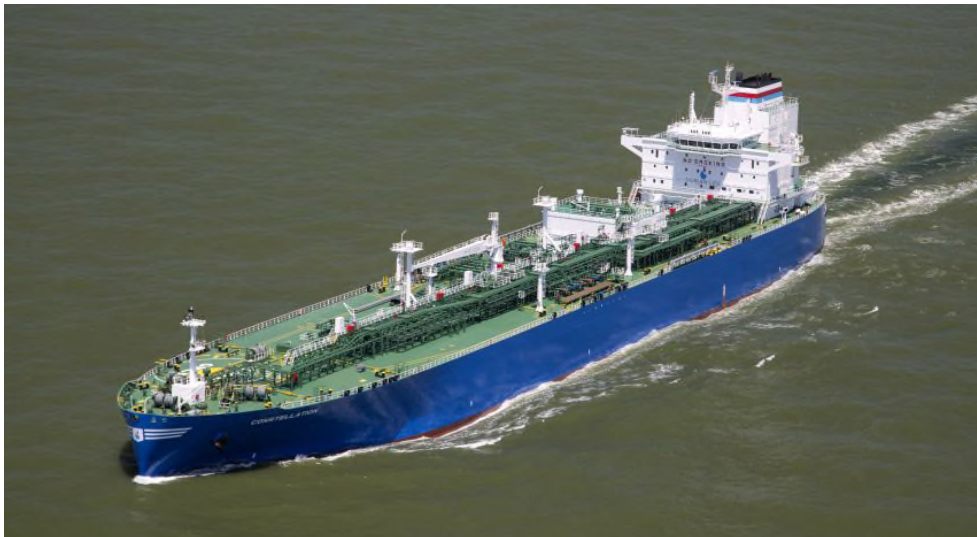
The Bahamas registered Constellation was a 225 metre liquid petroleum gas tanker. Constellation's 27 crew were made up of 19 Filipino nationals, three Ukrainian nationals, three Croatian nationals, one Russian national and a Latvian national, who all held appropriate qualifications for their respective roles on board.
